OUTLINE OF REPAIRS

1. FILM ADVANCE & SHUTTER RELEASE MECHANISMS

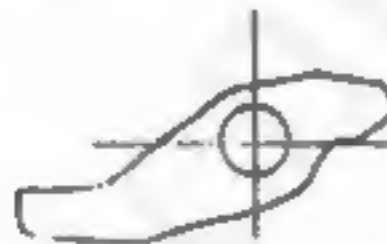
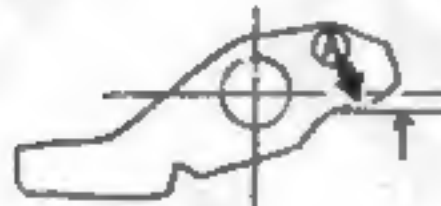
1) Improper selection of CA8844 (Lever)

8844 is available in following 3 types. Adjustment should be made on the timing of brake release by replacement of 8844 with a proper type.

Some of 8844 are bent for adjustment of engagement between 8828 (Shaft) and 8833 (Plate). This should be checked at the time of replacement.

If, even upon replacement with 8844C, the film advance motion is not smooth yet, the portion marked A may be slightly hammered out. (Do not work excessively, as it will cause the spring to be readily pressed from the beginning of the motion.)

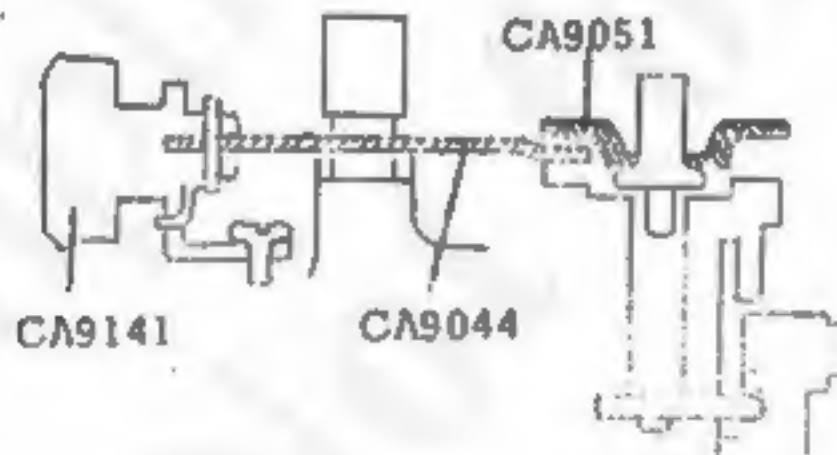
2) CA9051 (Plate) stuck with CA9044 (Plate)

When 9051 is extremely deformed, replacement is required. Clean the sliding portion of both 9051 and 9044, and apply small amount of Molicote (Grease) Type U.

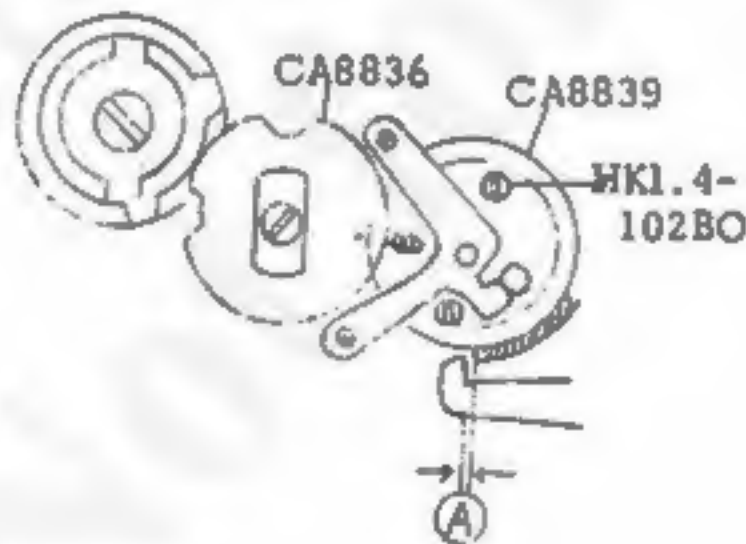
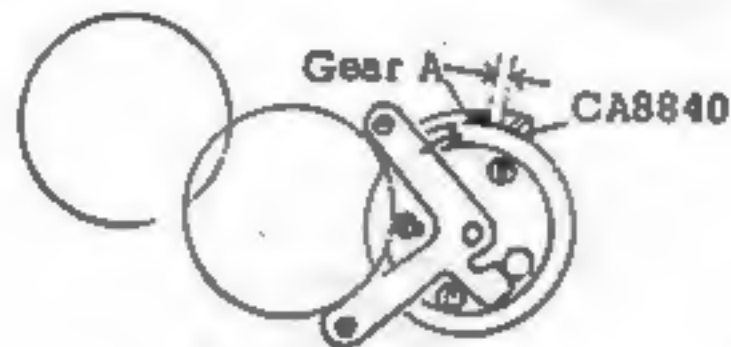
1) Improper adjustment of Eccentric Screw (8809)

Prior to film advancement, when the Gear A is pressed in the arrowed direction, the distance between 8840 and the Gear A should be $-0.10 \sim +0.3$. (-0.10 means the state where the Gear A comes in contact with 8840 and further moves by 0.1.)

In case of insufficient film advancement, loosen two HK1.4-102BO to widen the distance at A by adjusting (8809).

In case of excessive film advancement, narrow the distance at A by adjustment of (8809).

Adjustment is similarly made by (8809).

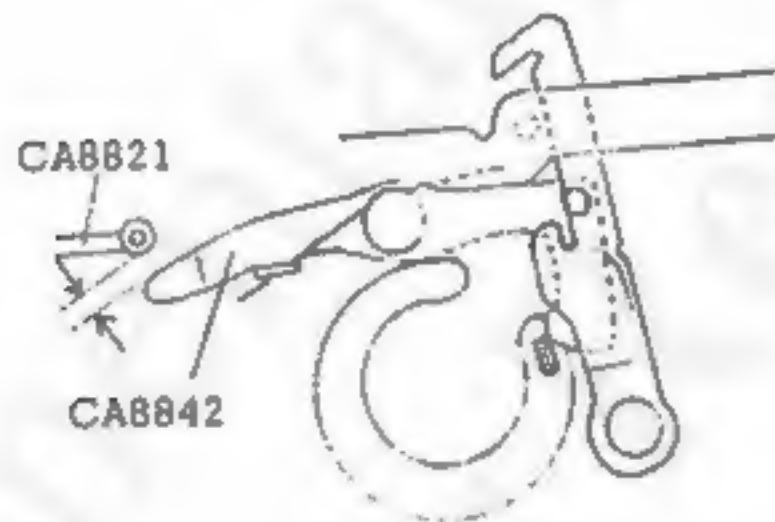
5. Locking device for the Film-advancing not operating properly

- (1) If the shutter cannot be released upon film advancement, check if 8842 (Lever) and the Stopper Ring of 8821 (Lever) are in contact with each other. They should not.

- (2) When the release button returns to its original position after the shutter release, 8862 (Plate) should return until its oblong hole hits 8864 (Shaft).
- (3) The operation should be accurately carried out from 8842 → 8821 → 8824 until CA8824 hits the CA9053 of the body.

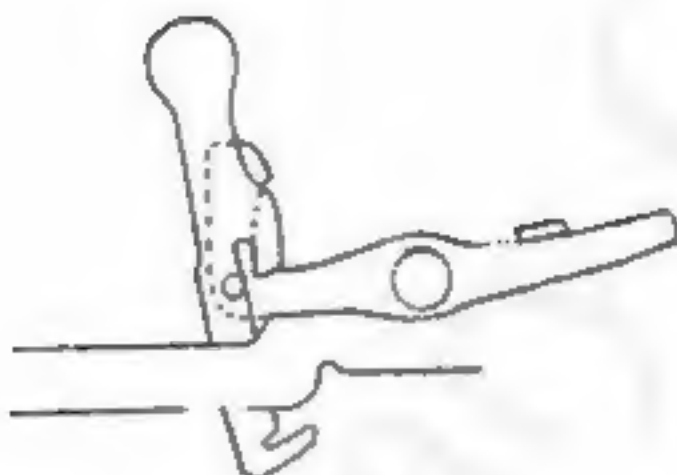
6. The shutter can be released during or prior to film advancement.

Check the operation of related parts. If the shutter cannot be released even upon film advancement, make sure 8850 (Pin) is not hitting 8810 (Plate).

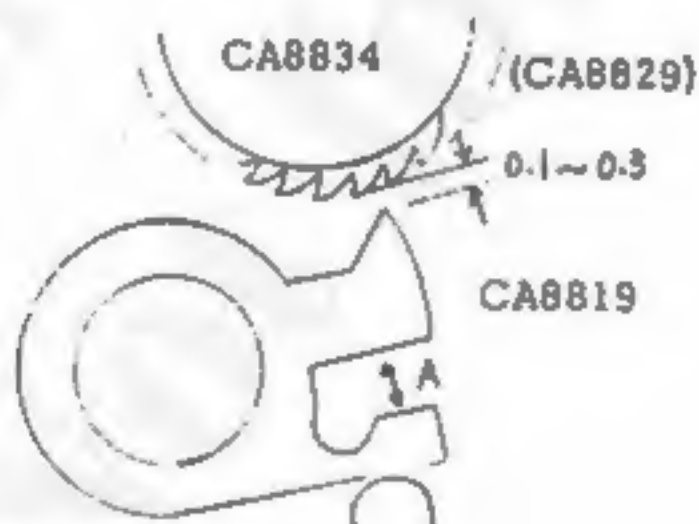
7. Shutter cannot be charged.

- 1) Improper operation and/or adjustment of CA8819 (Claw)

- When the film advance lever is returned to its original position during the film advancing operation, 8819 should engage onto (8829) to prevent reversion of 8834. (Apply force on the sprocket.)
- During the film advancing motion, 8819 should stay away from the (8829) with a distance of 0.1~0.3.
- 8819 should be in engagement with 8829 for more than its own (8819) thickness in the vertical direction.

Refer to the checkup column. Adjust the distance A on 8819.

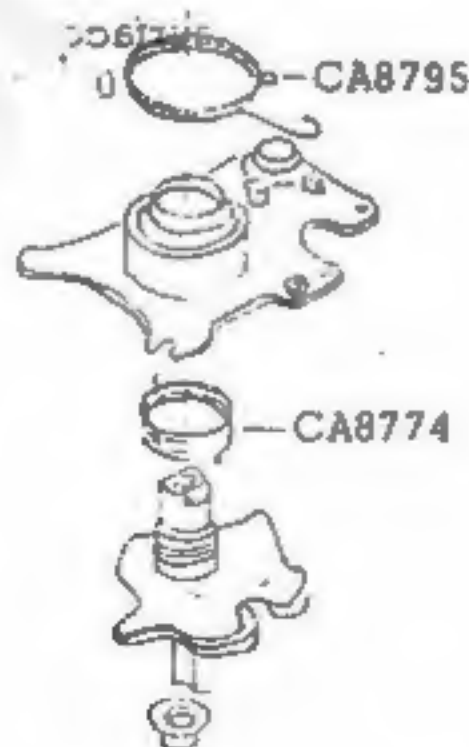
- 2) CA8774 (Spring) and CA8795 (Spring) worn out, broken or entangled.

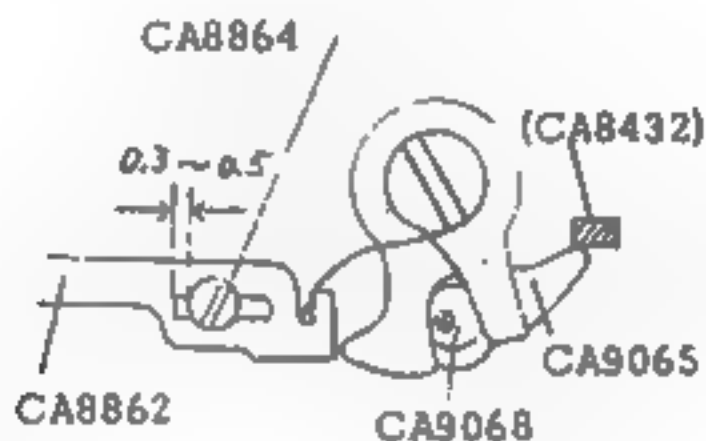
10. The shutter releasing position of the button too deep or too shallow.
Excessive or insufficient leeway in the button motion after the shutter release.

1) Improper adjustment of CA9068 (Collar).

9068 should be adjusted so that the mirror commences its operation when the distance between the oblong hole of 8862 and 8864 at their edges is $0.3 \sim 0.5$.

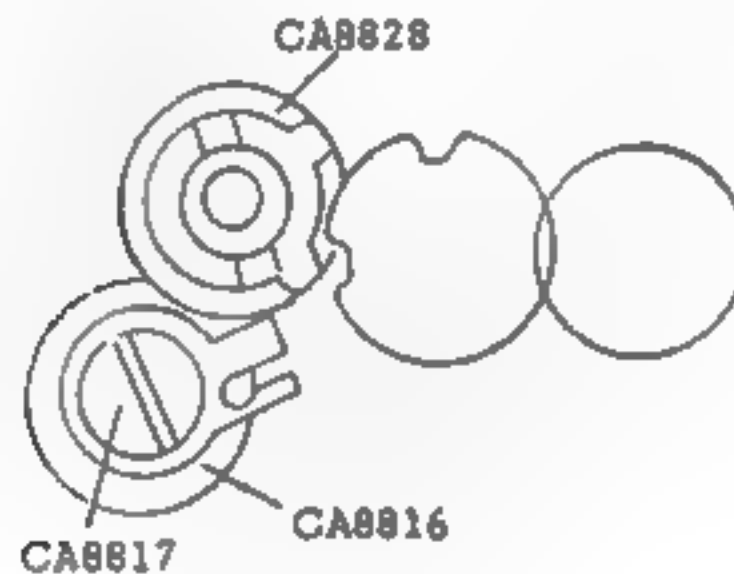
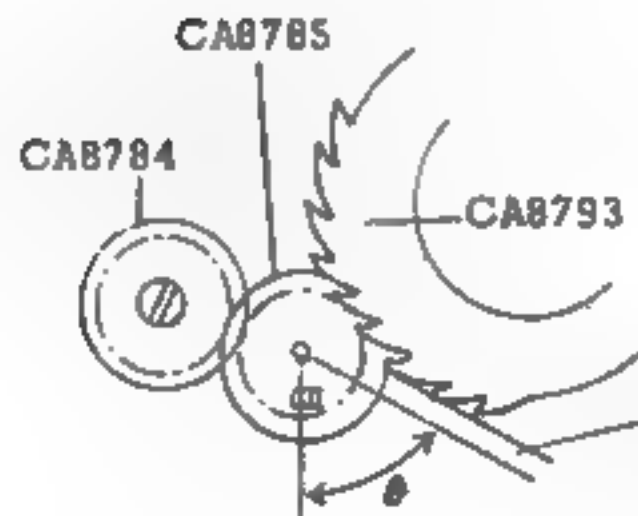
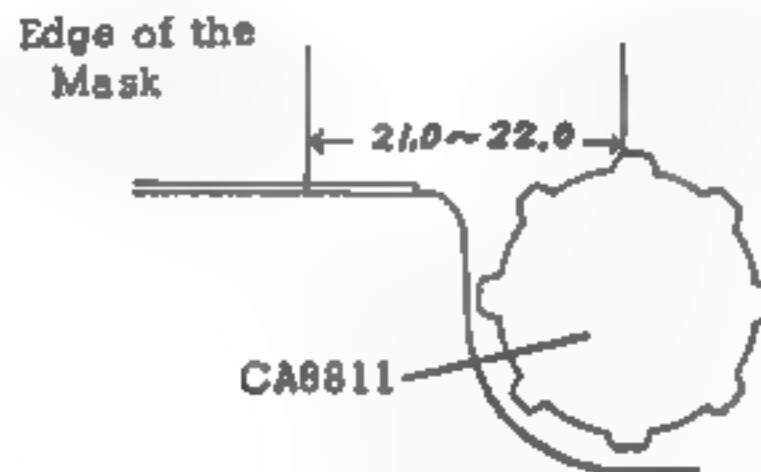
12. Uneven intervals between picture frames.

1) Improper positioning of Sprocket Teeth

The clearance between boss of 8785 and 8793 should be over than 1mm.

When the Sprocket is pressed toward the Mask, the distance between the edge of the Mask and the Sprocket Teeth should be 21.0 - 22.0 mm.

After the film is advanced and locked, bring 8785 (Gear) to rise within the range ϕ , and make following adjustments:

Loosen 8817 (Screw) and change the position of engagement between 8816 (Gear) and 8834 (Gear).

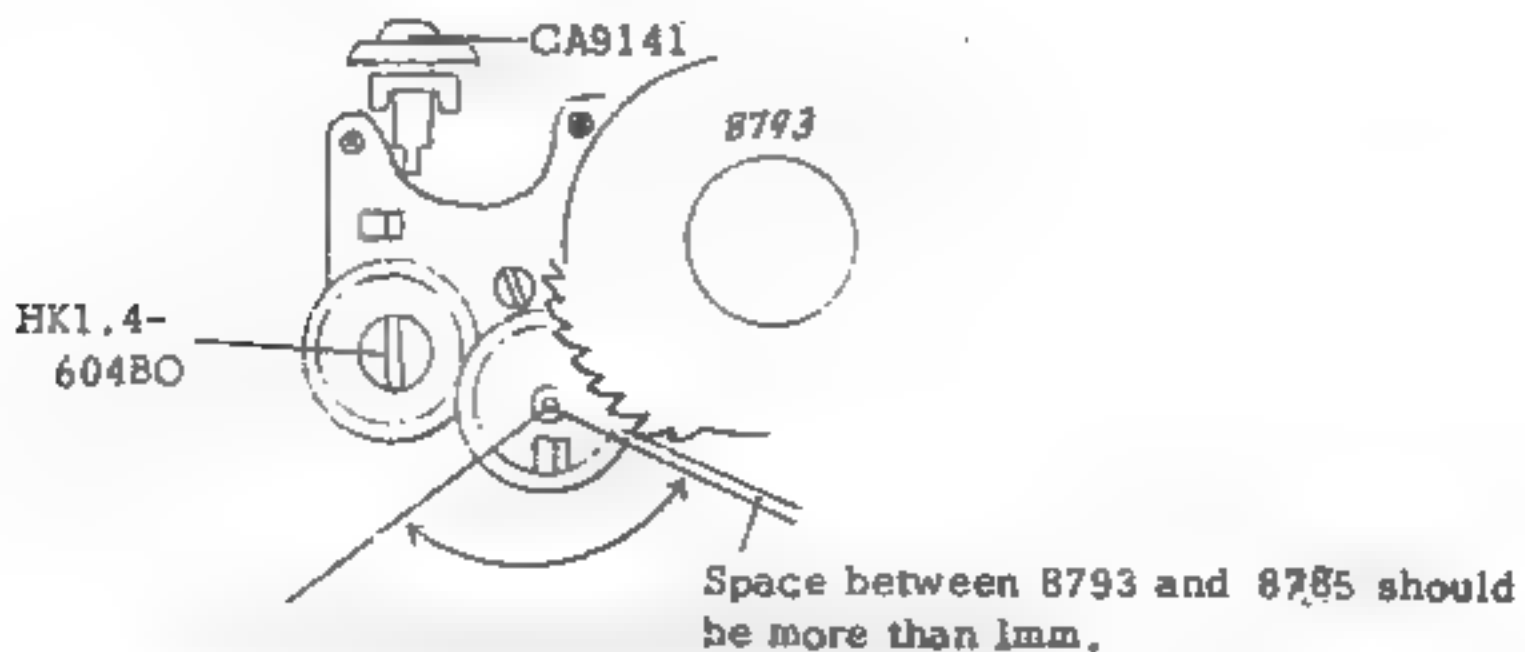
1) Improper positioning of CA8785 (Gear).

Set 9141 and loosen HK7.4-604 BO on 8784 to let it rise and adjust 8785 position. Upon completion of film advancement, 8785 should be positioned as follows (within the range shown by arrows.)

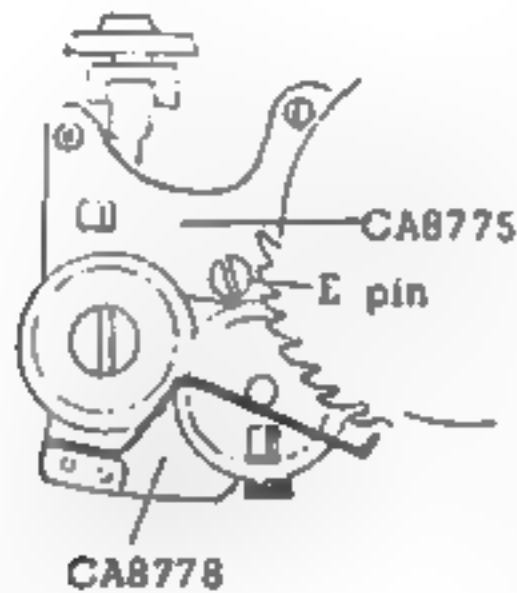
2) Improper positioning of CA8778 (Lever)

Keeping the E pin of 8775 at the neutral position of its eccentric motion, bend the Plate (A) so that 8778 will hit the E pin when the Rear Cover is closed.

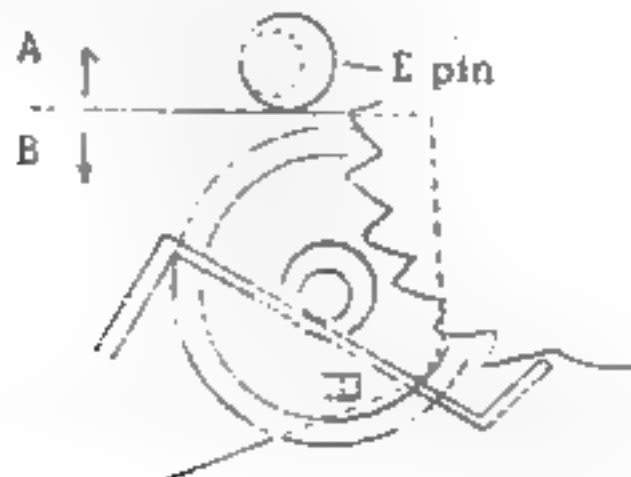
4) Improper position of CA8790 (Stopper)

When the Rear Cover is closed, the tip of (8790) should hit the bottom of the teeth of (8793). If it does not, an adjustment should be made by bending (8790) at the S position. Some room may be permissible between (8787) and (8790).

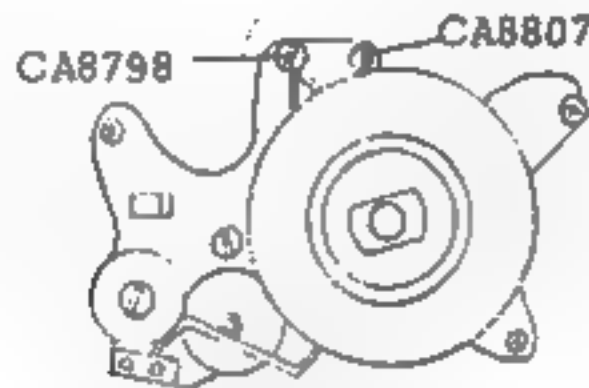
14. S point of the Film Counter Plate out of position.

1) Adjustment of CA8807 (Pin)

Loosen 8798 and adjust eccentricity of 8807 so that the tip of (8790) touches the bottom of the first tooth of 8793.

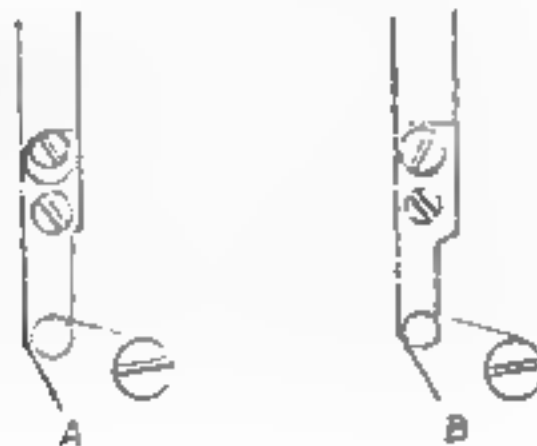
15. Little leeway stroke after the shutter release by the self-timer.

The duration of operation of the self-timer is to be 9 - 14 seconds when it is fully set. The leeway stroke after the shutter release should be 0.2mm or above.

A : Bigger leeway stroke after the shutter release and shorter self-timer operation.

B : Little stroke after the shutter release and longer self-timer operation.

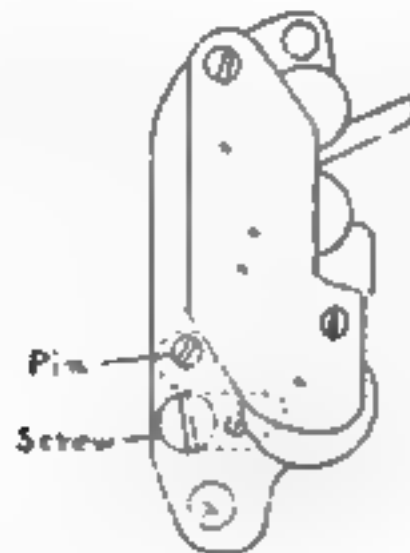
16. ST lever not pointing straight up.

Loosen the screw and adjust the S stopper pin (eccentric).
After adjustment, tighten the screw fully and bond it with Aron Alpha.

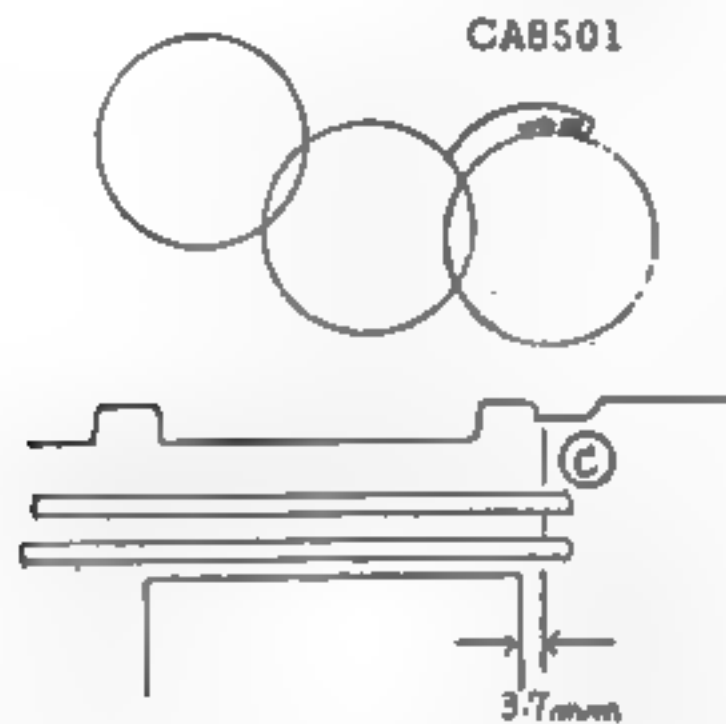
2) 1st curtain stops at the improper position.

If it does not, an adjustment may be made by moving vertically the mounting position of 8517 (Stopper) assembled in 8519 (Shaft).

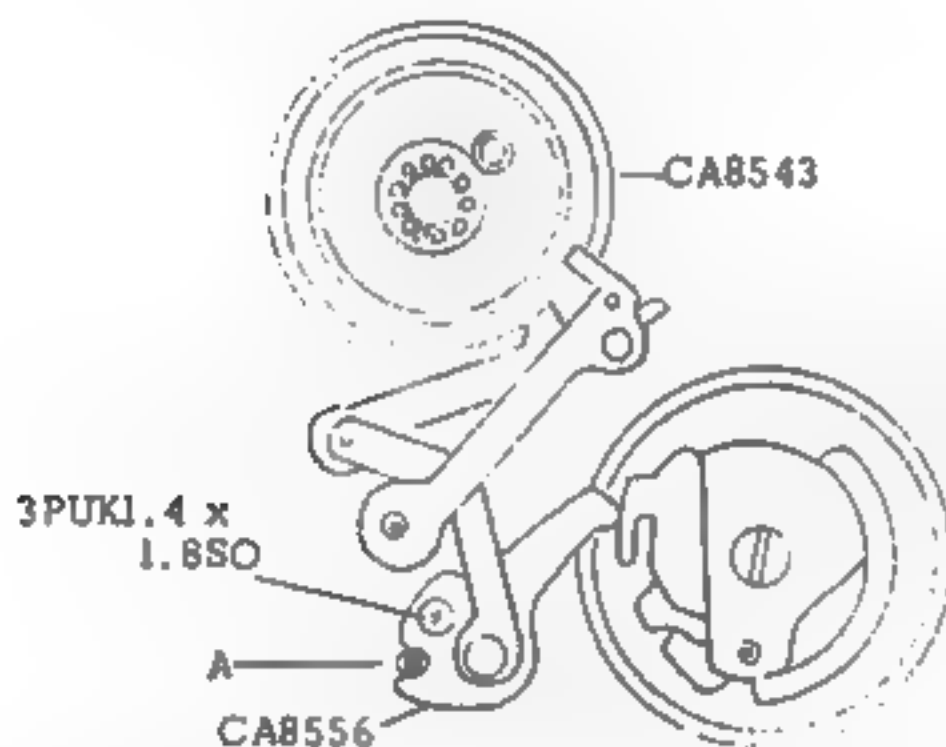
5. Improper timing at high shutter speeds:

If the speed at $1/1000 - 1/60$ sec. is in average longer (or shorter) than the proper timing, and adjustment is to be made with A of 8556 (Lever).

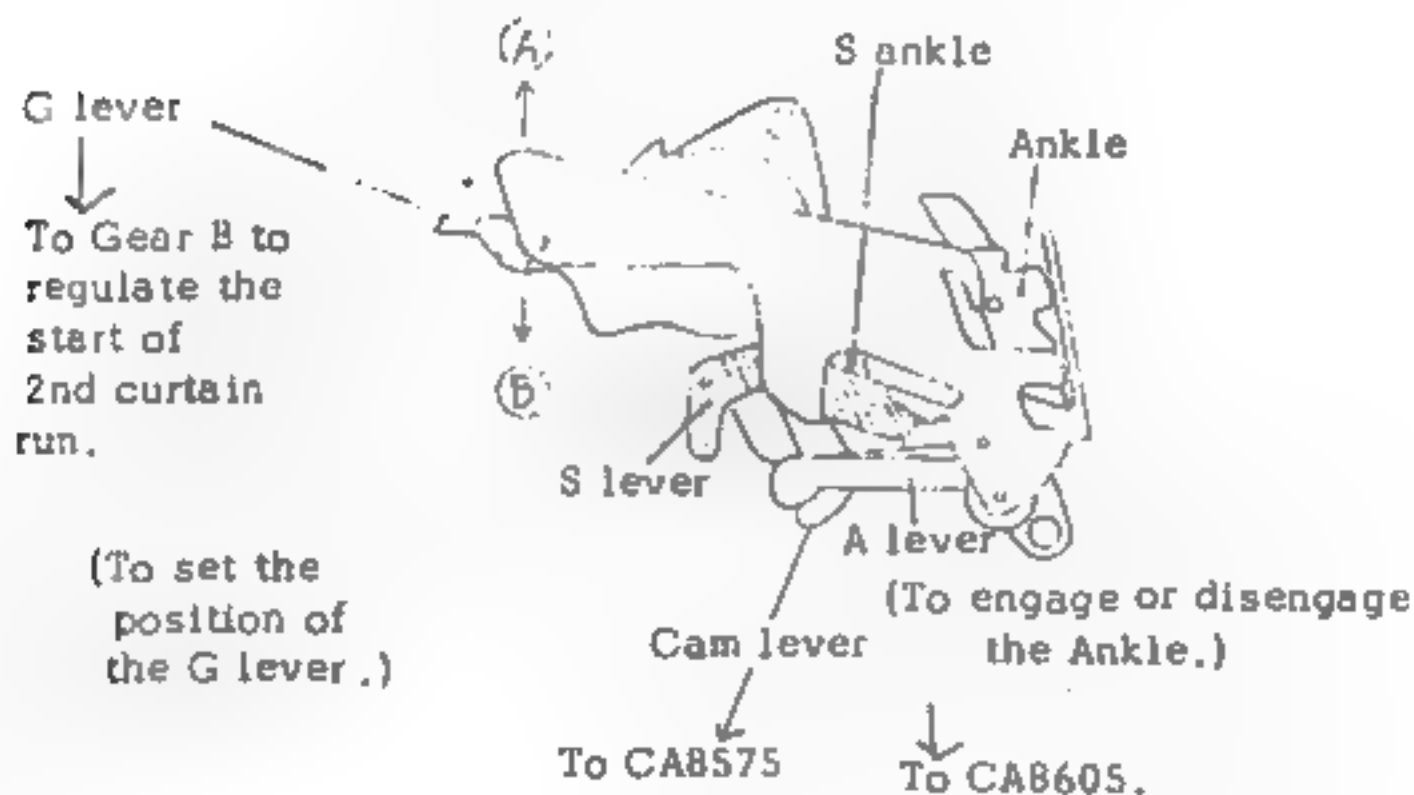
6. Improper timing at low shutter speeds:

If the speed at 1/30 - 1/1 sec. is in average longer (or shorter) than the proper timing, an adjustment is made by moving the governor. When it is longer, the governor is to be positioned rather towards the direction A, and when shorter towards B.

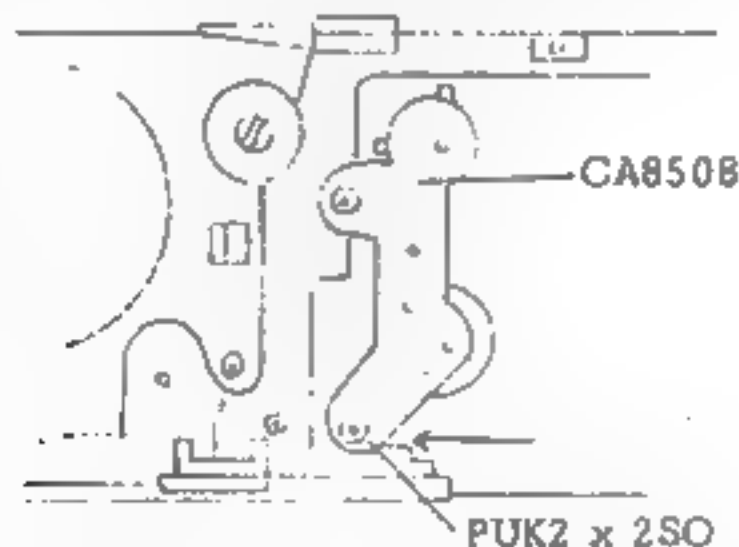
In case where the Shaft rattles vertically due to deformation of 8508, insert a U washer (0.1 - 0.2) underneath the Plate R on the arrowed side.

Loosen two PUK2 x 2SO of 8508 and adjust the position of 8508. Check for inclination of 8519 and 8520 and make necessary adjustment.
